DUBRE, KY.

## LANDSLIDES AND RELATED FEATURES

OF THE DUBRE, KY. QUADRANGLE

OPEN FILE MAP 82-653(G-4)

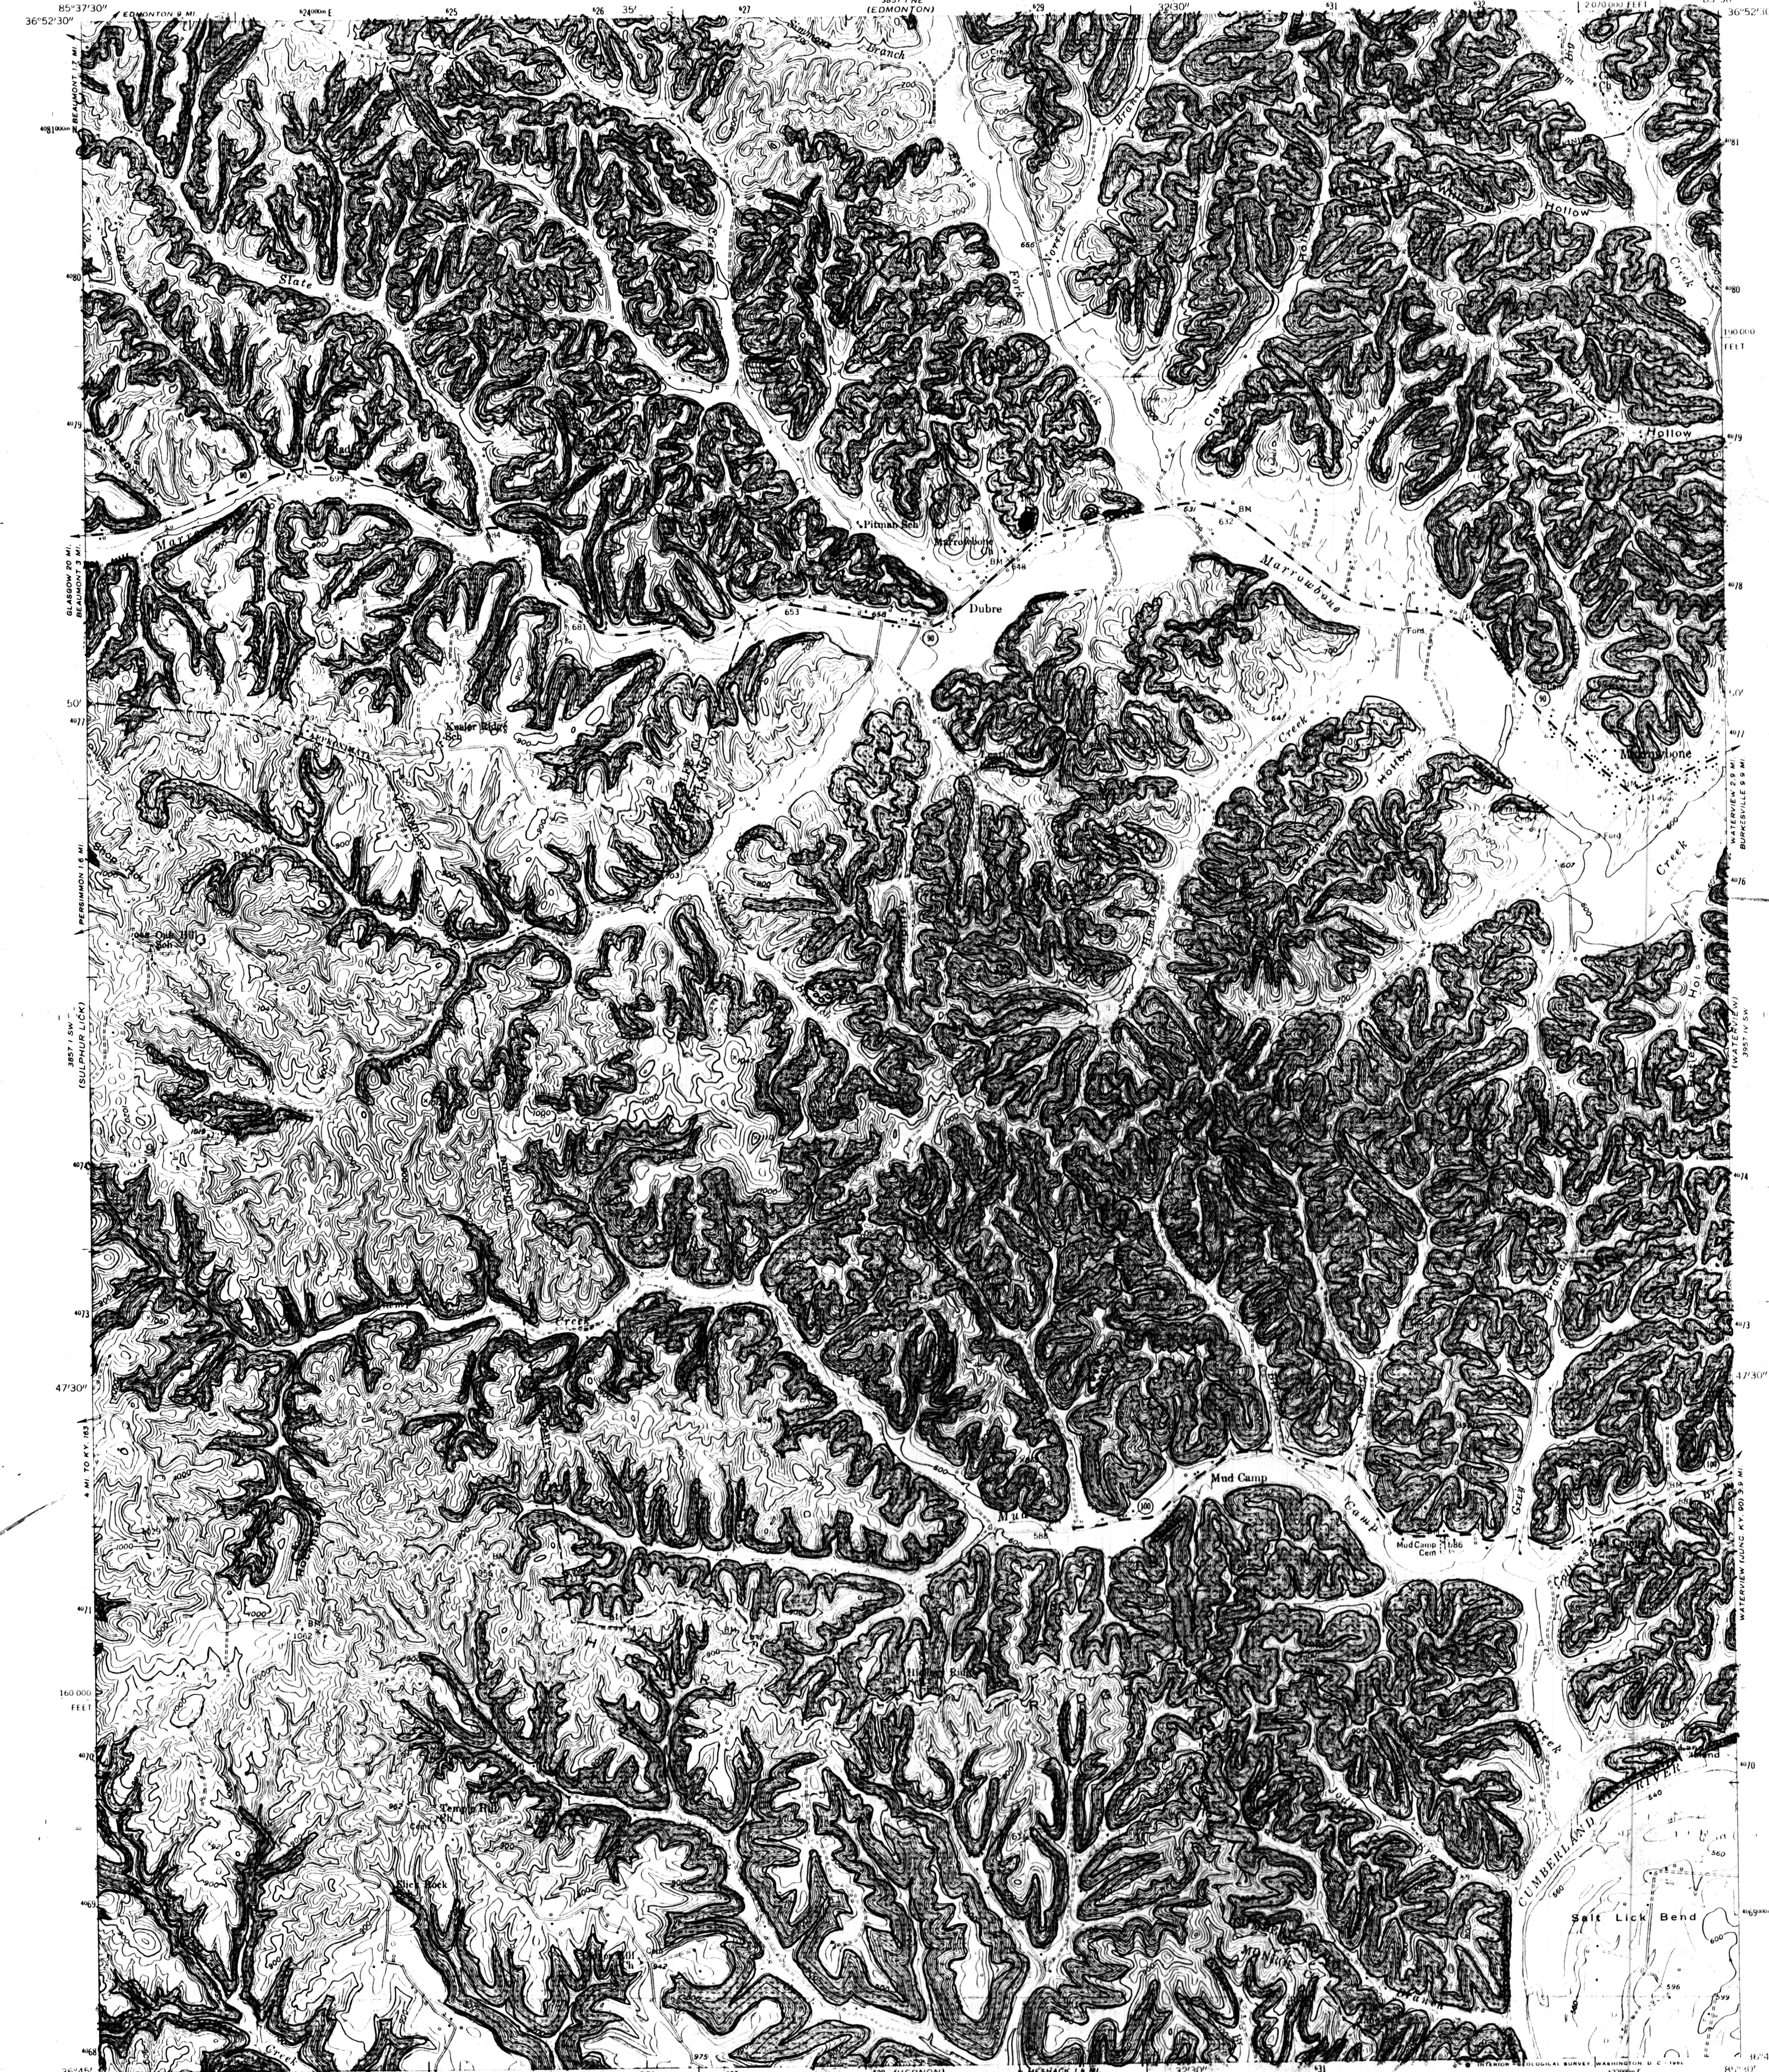
Landslides and related features interpreted from aerial photographs:

### ACTIVE OR RECENTLY ACTIVE LANDSLIDE

Complex landslide composed of earthflow, debris slide, earth and rock slump. Identified from historical records, and from scars, debris and other field evidence. Ground extremely unstable; sliding accelerated by excavation, loading and changes in drainage conditions. May include areas with several active slides too small to be shown separately. Questioned where doubtful.

### OLD LANDSLIDE

Area of extensive hummocky ground caused by earthflow and earth and rock slump. Lacks clear evidence of active sliding. Relatively stable in natural, undisturbed state, generally not affected by small structures properly sited in areas away from the edge of the toe; can be reactivated by extensive, rapid excavation, loading, and changes in ground water and surface water conditions. Area of old landslide probably includes recent ones not identified from field evidence or otherwise documented. Upslope boundary of landslide generally defined by modified scarp, but downslope (toe) may be gradational and not well defined. Questioned where doubtful.

### COLLUVIAL SLOPE

Valley wall along major streams with slope as steep as 40° (85%); stony, clayey silt soil up to 50 ft. (15 m) thick; commonly buttressed by a terrace or bench at the toe of the slope; very susceptible to sliding by cutting of toe area, removal of terrace or bench, and overloading; slide commonly activated without apparent cause.

### AREAS SUSCEPTIBLE TO DEBRIS FLOWS AND DEBRIS AVALANCHES

Primarily shallow, narrow ravines and chutes with accumulation of stony colluvium generally 10 ft. (3 m) or less in thickness; susceptible to rapid movement during intense rainfall. Most ravines and chutes designated show evidence of former debris flows and avalanches.

### AREAS SUSCEPTIBLE TO ROCKFALL

Steep, locally vertical, natural and man-made slopes and cliffs, 15 ft. (4.5 m) or more high; formed dominantly of sandstone, limestone, sandy shale, mudstone and claystone. Interbedded mudstone, claystone and shale weather rapidly leaving sandstone and limestone rock faces unsupported.

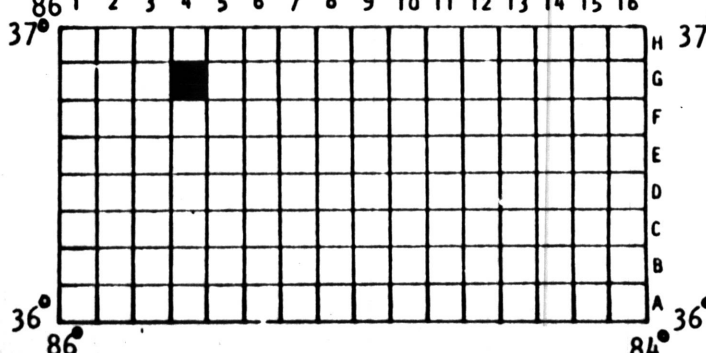
CORBIN 1 by 2 SHEET

The first five digits of the open file number designate the specific 1:250,000 scale map sheet of which this quadrangle is a part. The last two digits designate the position of the quadrangle in a subdivision of the 1:250,000 scale map based on rows and tiers shown in the diagram to the right. The location of this quadrangle is shown by the black square.
